Eagle Scout Project Pictorial from March 11, 2006

The following pictures are from an Eagle Scout Project that was recently completed at Walnut Creek Park. The Scout and his parents approached CAMBC about performing a community service project or specifically an Eagle Scout Project at Walnut Creek. CAMBC helped by providing tools, technical help, and by arranging contacts for appropriate paper work with Albemarle County.

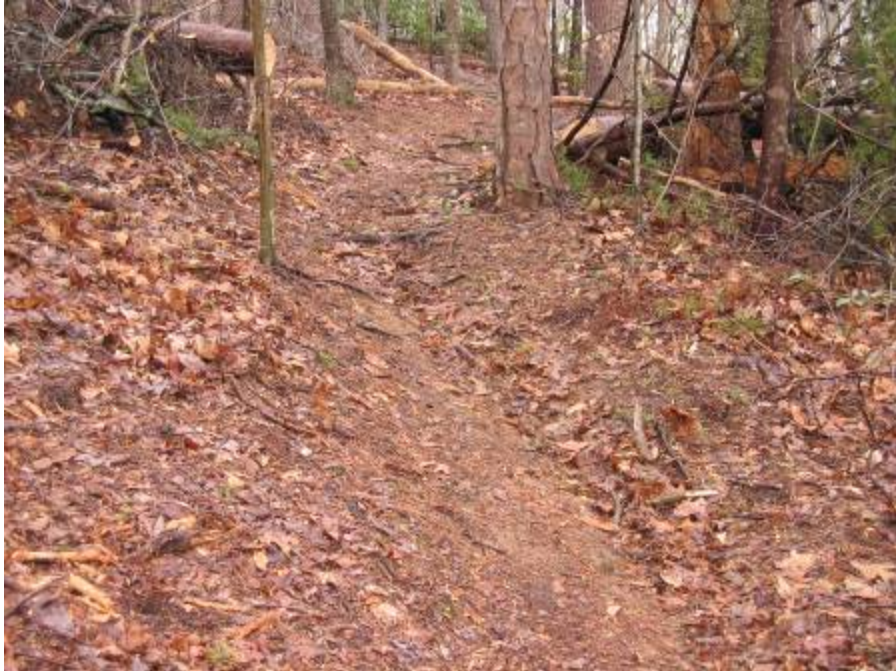
This unsustainable section of trail was identified as a reroute candidate for the Eagle Scout Project. The trail tread runs straight down the hill without any grade reversals. Note the “V” shaped gully from water based erosion.

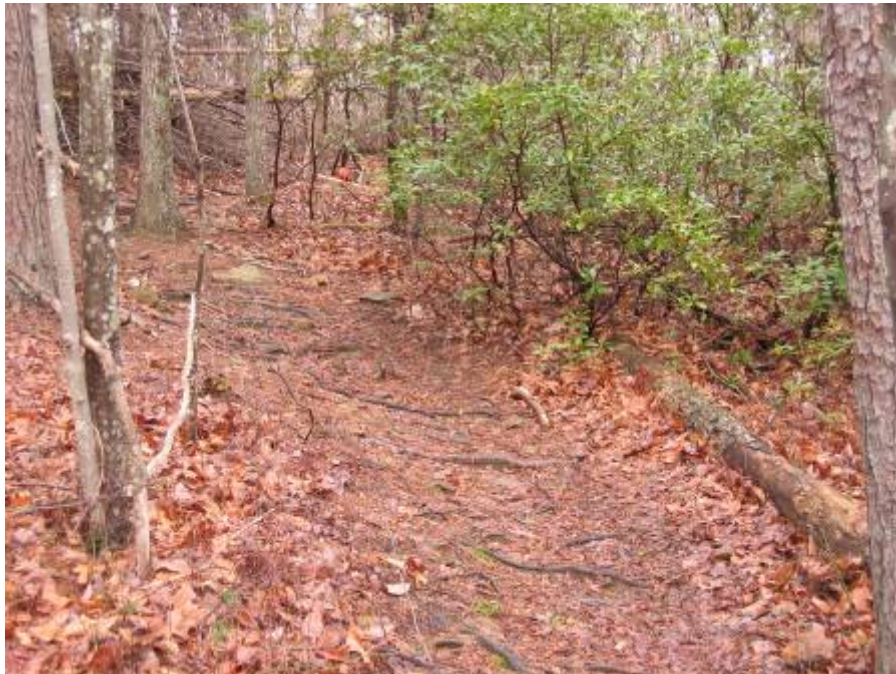
This is another view of the same unsustainable section, too steep, for too long. Water based erosion has exposed many roots, causing users to widen the trail by selecting more walkable and rideable lines.

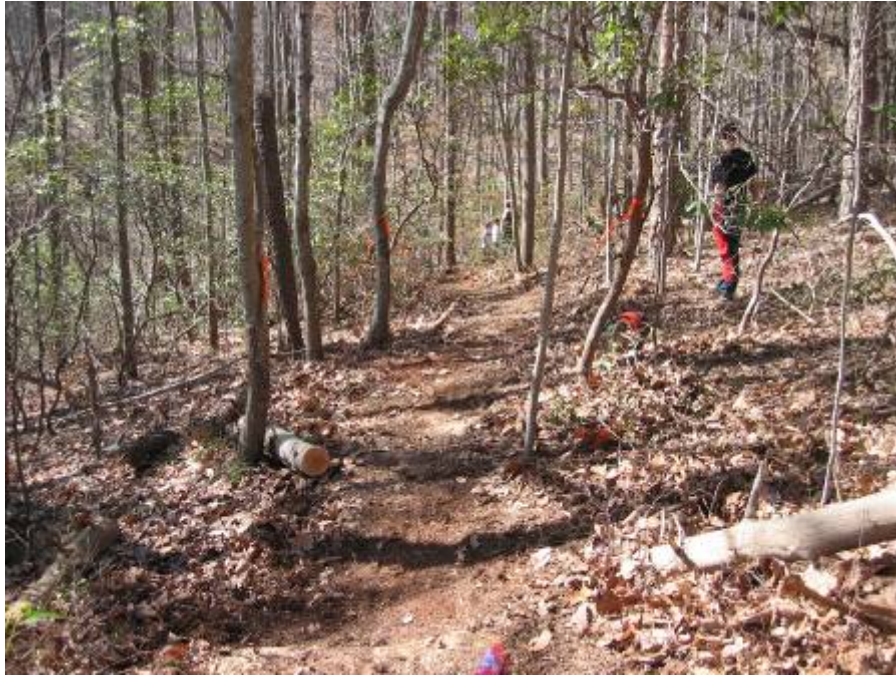
View of the reroute while under construction. The reroute uses a sustainable grade, going across a side slope, and it has grade reversal features for drainage.

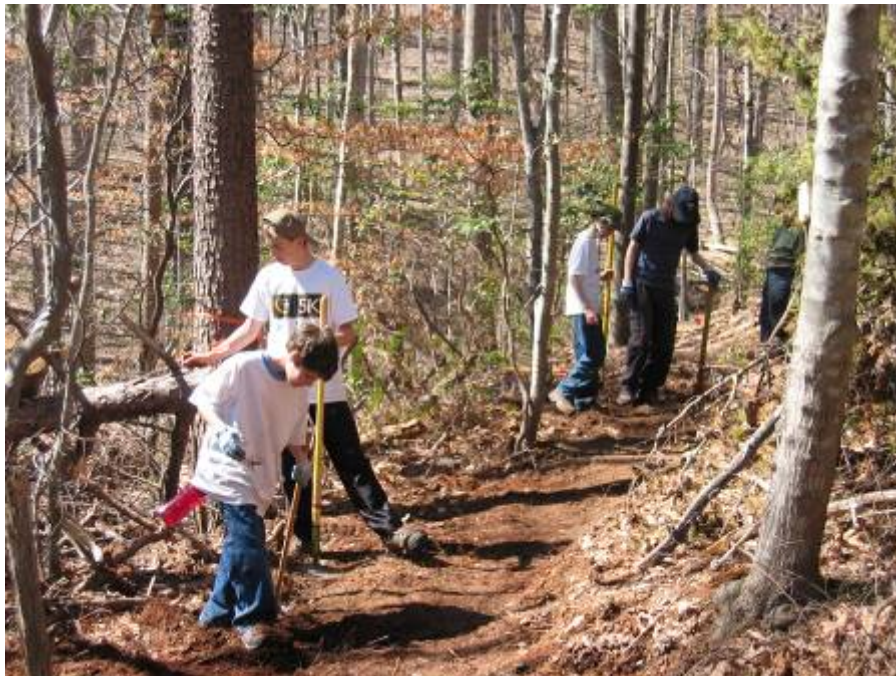
The Scouts at work making a “bench” cut.

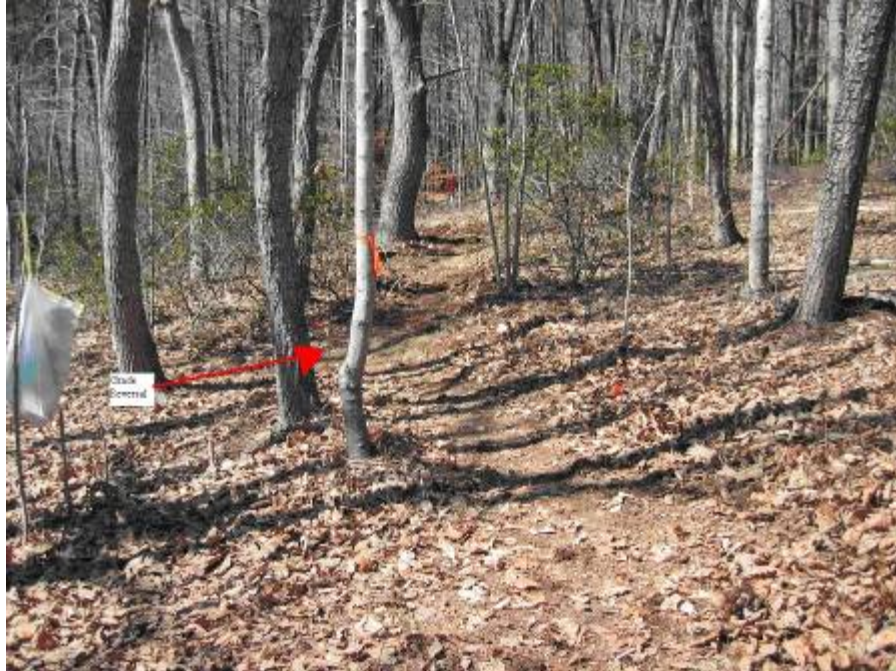
This is a view of the new route. Note the frequent grade reversals which divert water from the trail tread surface before it picks up speed and volume.

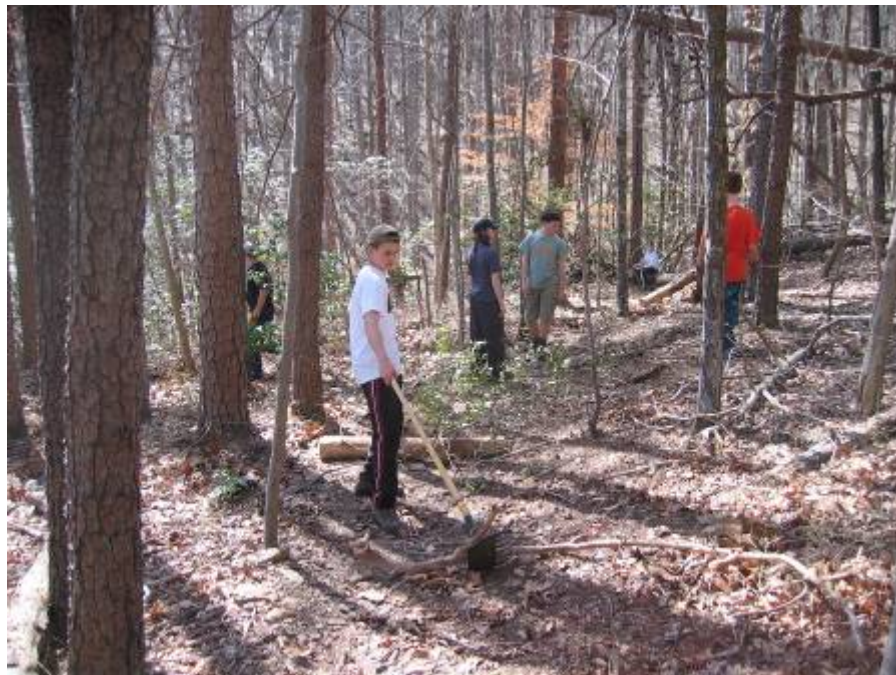
This is a view of the old trail being returned to a natural state or “reclaimed.”
